Manhole Inspection Summary

Manhole # S33AA1006MH

Insp Date: **3/5/07 11:03 AM**

Location Address: **GREENWAY**

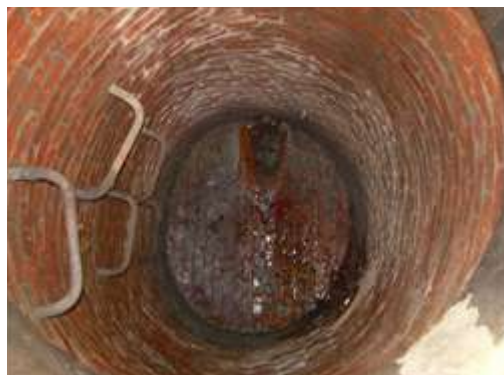
Top View

Frame leaks. Adjustment infiltration.
Corroded steps. Channel debris.

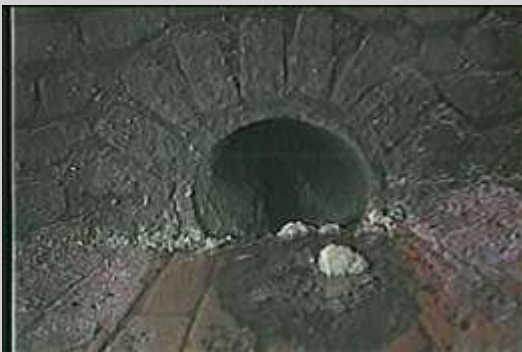
8 in. Circular Gravity Sewer Pipe Out @ 12 O'Clock

Deposits: ☐ None ☒ **Mud** ☐ Sludge ☒ **Debris** ☐ Grease

Silt Depth: **0.5** (in.) Deposits Extent: **Light**

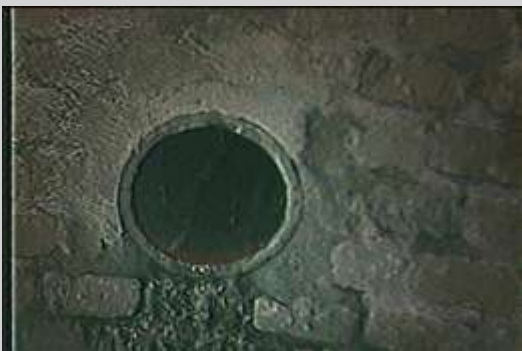
6 in. Circular Gravity Sewer Pipe In @ 4 O'Clock

Infiltration: **Evidence** Pipe Seal Cond: **Unknown**
